What is an Invalid Memory Reference?

Associated Part Family: CY8C21x23, CY8C21x34, CY8C24x23A, CY8C27x43, CY8C29x66

Software Version: PSoC Designer 4.2

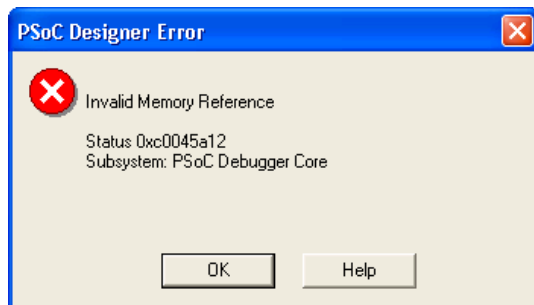
Figure 1. Invalid Memory Reference Dialog Box

The Invalid Memory Reference (IMR) error occurs when the internal states of the In-Circuit Emulator (ICE) and Pod diverge. There are multiple possible causes for this divergence. An IMR is reported when the PSoC Designer debugger detects a mismatch between the emulated M8C registers and SRAM in the ICE-base station, and the registers and SRAM in the PSoC® device on the emulation Pod. You can think of an IMR as the result of the ICE losing track of what the Pod is doing.

The IMR errors must be fixed before you can continue debugging. Many reasons why IMR errors occur are fixed in the most recent versions of PSoC Designer and current generations of the PSoC microprocessor. You can work around IMRs or prevent the remaining IMR issues using proper methodology in project code. An IMR does not necessarily imply that your application will contain faults when programmed into a part outside of the debugging environment.
